Confidential Inspection Report

**12345 SW Knight Dr.
Forest Grove, OR 97498**

Home Inspections Northwest, Inc.

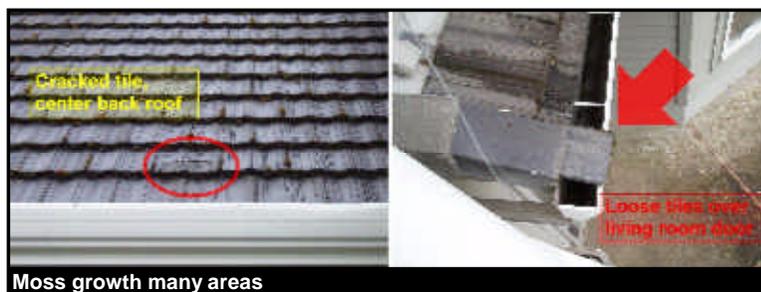
2.3 Tile Roofing

Further Review: At least two cracked or damaged tiles were observed at the rooftop. Additional tiles or adverse conditions may be found by a roofing professional.

We recommend further review of the roof system for a better understanding of present condition and repair/replacement costs.

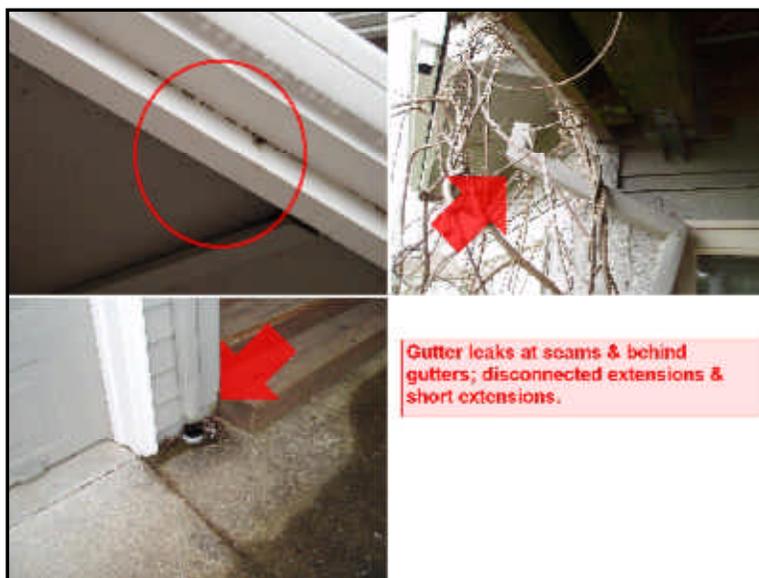
2.11 Gutter/ Scupper Condition

Repair: The gutters exhibit signs of leaks. We recommend that the gutters be repaired.

Repair: The building's gutters were made of metal. The gutters drain at or near the building, this condition allows surface water to build up against the foundation and possibly enter causing moisture related issues.

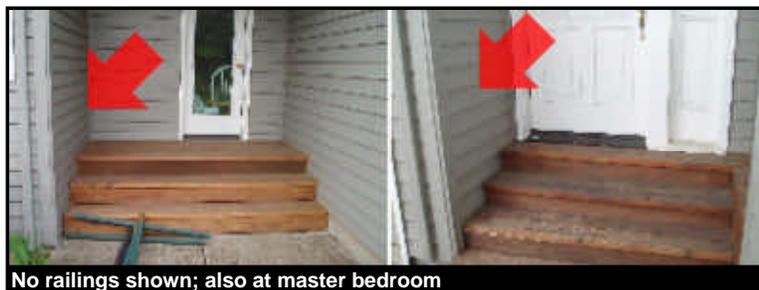
3.10 Railing Condition

Safety Concern: No railings were provided at several entry steps to the house. Railings should be installed to reduce the potential for personal injury when there are three or more steps. We recommend that the railing be installed. This is a safety concern.

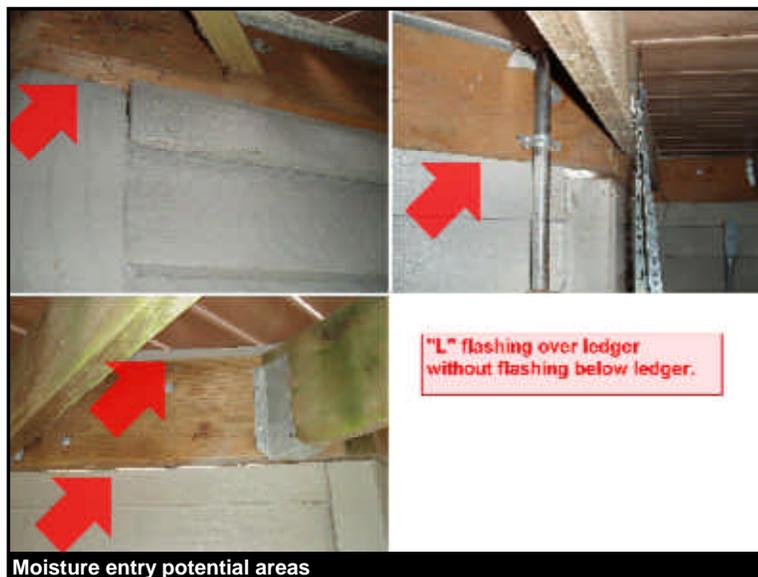
3.13 Deck Condition

Repair: The "L" flashing present may allow water to get behind the ledger causing moisture damage as water can still get under the flashing. We recommend further corrective measures to keep water out.

Repair: Flashing areas around the deck need to be sealed. Allowing water to penetrate into the wall is destructive to the structure. Attention is required and we recommend that the deck flashings be corrected to prevent water intrusion and damage.

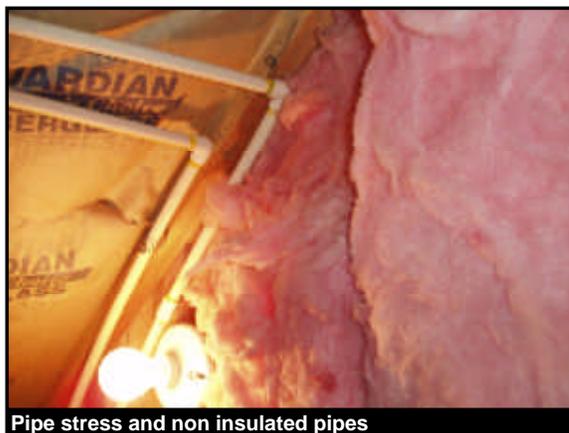
7.6 Distribution Piping Condition

Pipe stress and non insulated pipes

Repair: One or more water lines are not insulated in areas which are vulnerable to

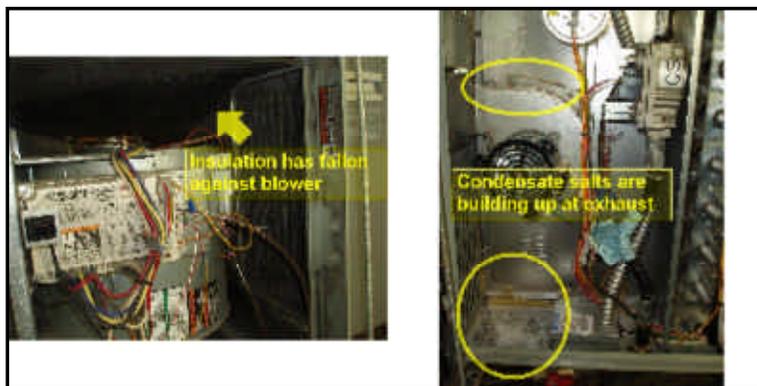
8.6 Heating System(s) Condition

The heating system operated but the interior components are covered with lint, dust and/or grime.

Maintenance: Dust and/or debris have built up on the blower and in the blower compartment. We recommend the blower and compartment be cleaned and the blower's bearing be lubricated.

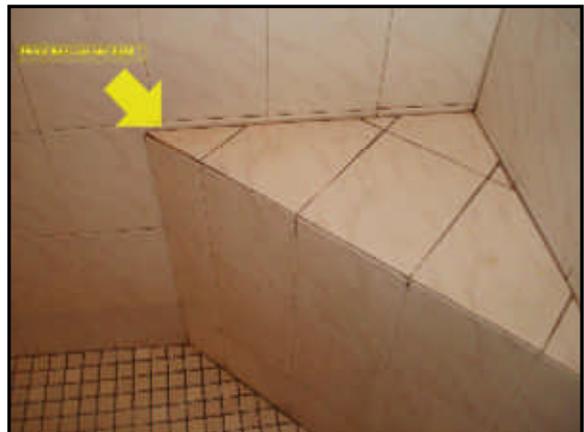
Repair: In the master bathroom, missing or deteriorated grout was noted at the shower/tub wall area. The possibility of a moisture issue behind the wall is present. We recommend re-grouting and sealing to reduce water penetration and possible damage to the surrounding areas.

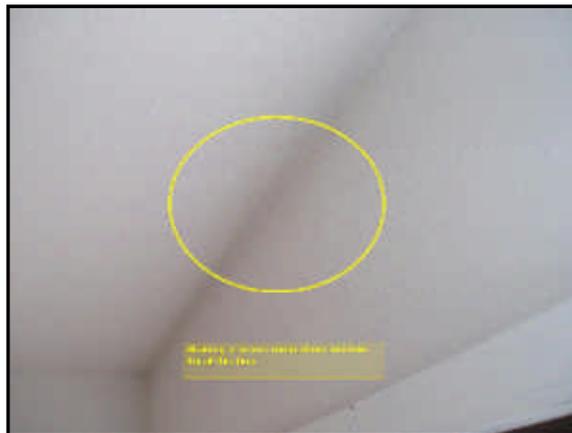
11.8 Ceiling & Wall Conditions

Consult Seller: Water stains were observed on the ceiling in the bonus room indicating a past or present leak. Consulting the seller as to any repairs made may be one way to identify an old stain from an active leak. Monitoring the stained area(s) is recommended if repairs have been made. If no information is available from the seller we recommend further review for a better understanding of repair costs and present condition.

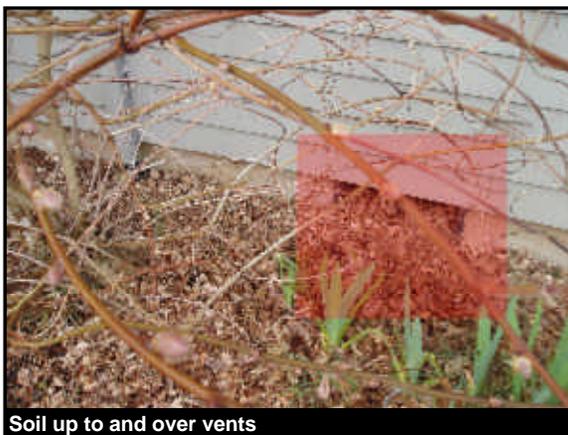
14.12 Ventilation Conditions

Repair: Crawlspace ventilation was observed to be below soil level. The bottom of the vent should be 4" above the soil level. We recommend clearing the vents for proper air flow of the crawl space and adding vent wells as needed to keep soil away.

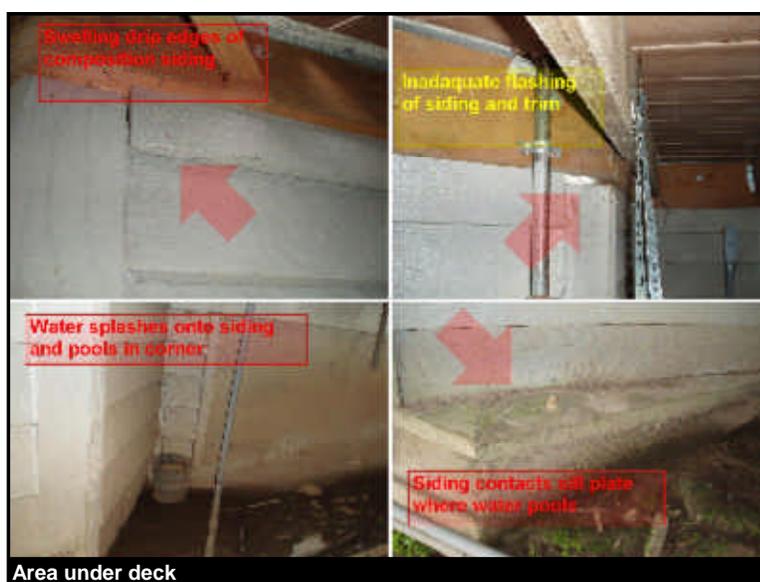
14.21 Siding Condition

Repair: The drip edge of lap siding is separating and further siding damage is likely. We recommend that all deteriorated wood be repaired or replaced.
